FIRST CONGREGATIONAL CHURCH OF LONG BEACH, CALIFORNIA

Restoration of 1914 brick and terra cotta church facades suffering extensive seismic structural damage, and spalling caused by corrosion of steel armatures and anchors in a marine climate.

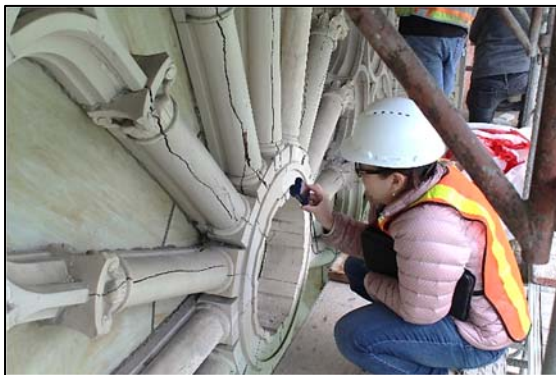
Inspection of cracked Rose Window tracery

The ceramic window tracery was extensively damaged by multiple longitudinal cracks and spalls, the latter caused by shear forces due to severely corroded mild-steel connection dowels and rods. The hollow terra cotta blocks had been located against a flimsy steel armature attached to the brickwork, and kept in place with a few wire ties and crude brick-aggregate concrete packing. Lower down the façade, at Frieze and Plinth levels, large diameter steel dowels interconnecting blocks through their meeting sides, had also corroded and cracked many units. Elsewhere, accidental chips, scuffs and missing cornice edges provided evidence of terra cotta damage due to previous falling masonry.

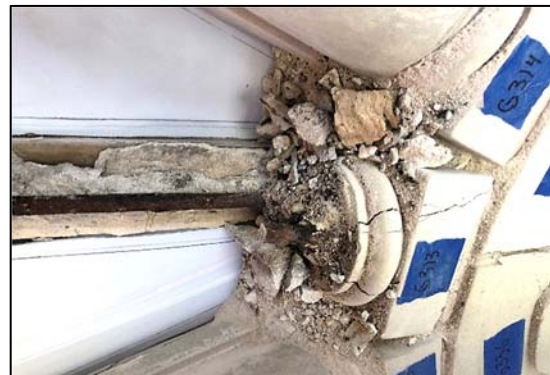
Spoke removed to reveal steel corrosion

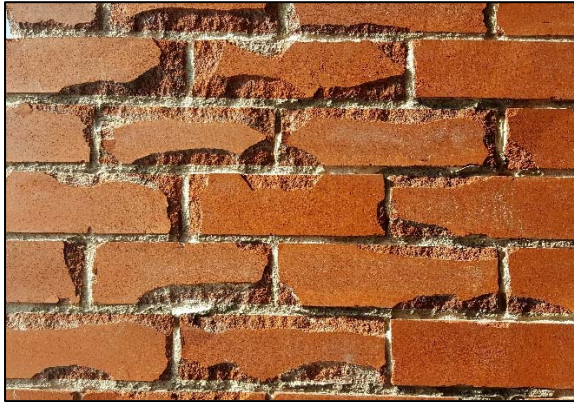
Spalled brickwork

Inspection of the brickwork revealed additional problems. The church architect Patterson originally specified a smooth red, sand-face, pressed brick for the outer wythe of masonry, and he must have known it was an absorbent material, because he also ordered an application of oleo-resinous water repellent to keep Long Beach's salty ocean mist out of the brickwork. However, the salt-laden moisture did penetrate the system over time, and cryptofluorescence developed behind the surface, resulting in the pressed brick faces spalling, particularly along joint edges. Furthermore, towards the top of the walls, at the heavy overhanging gable level, the corbelled brickwork of the faux machicolations was observed to be rotating and at risk of causing another structural collapse.

Superficial terra cotta damage would be left alone. And intermediate damage repaired by use of patching treatments. Rotating bricks would be 'pinned' to the substrate masonry with countersunk helical friction anchors. While spalled bricks would be replaced with new matching material bedded in lime mortar.

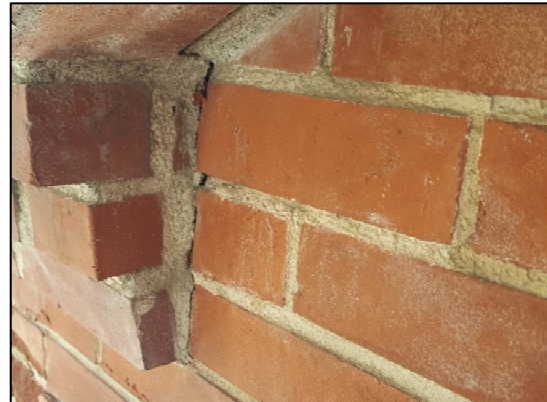
Rotating corbel bricks supporting the faux machicolations and overhanging gable.

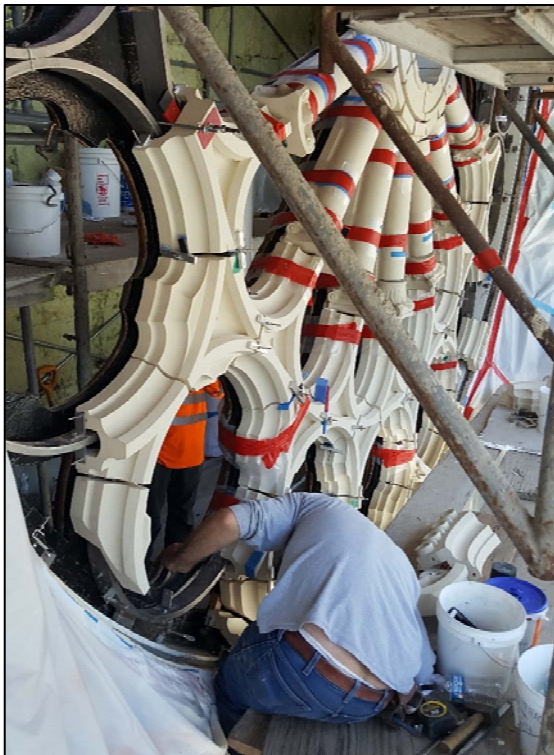
Master mason Shawn Tibbs installing units

New hollow terra cotta from England was then installed to replace the damaged blocks (surprisingly, originally from the Atlantic Terra Cotta Co., in Perth Amboy, NJ), each secured in place with stainless-steel anchor clips and neoprene shims. At the splayed rim, new terra cotta veneer pieces were installed on anchors as indents and their back cavities grouted solid.

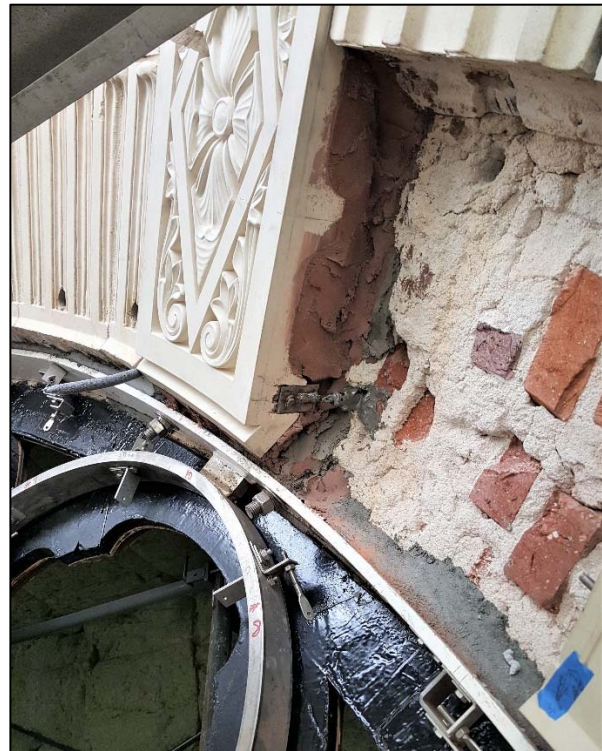
Keystone veneer installed for replacement

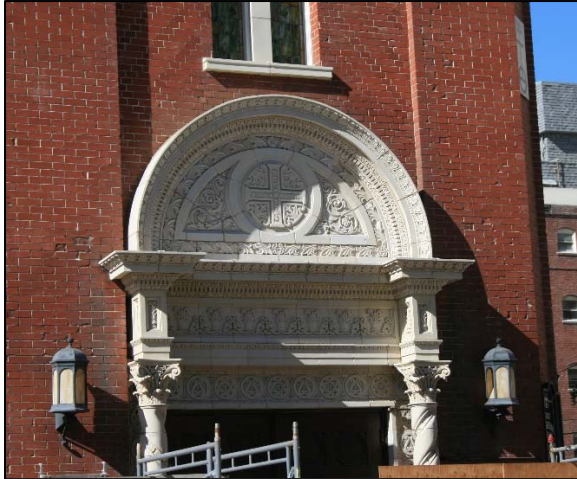
Tower porch cleaned and patch repaired

For the patch repair of extant terra cotta, the team specified Edison Coating's combined, custom color-matched kit-of-parts: Custom 45TC mortar, Thin-fill 55 mortar, Aquathane 210 coating and Aqua-Spec 220 speckle finish.

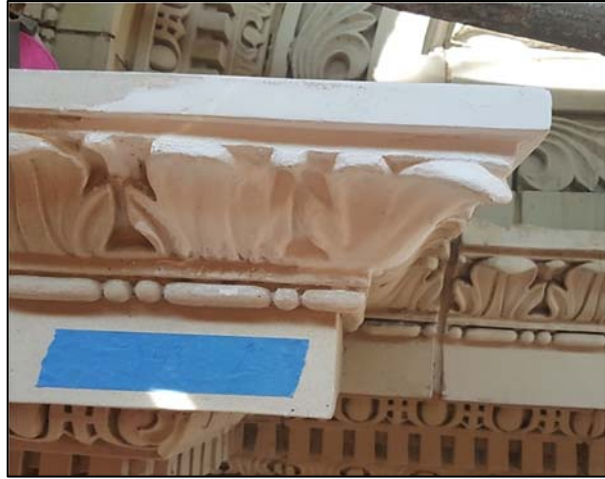
Porch cornice return recreated, part-way through restoration, awaiting additional carving and coatings

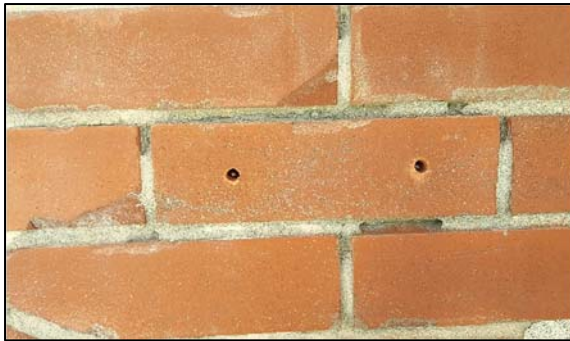
Counter-sunk helical friction anchors installed

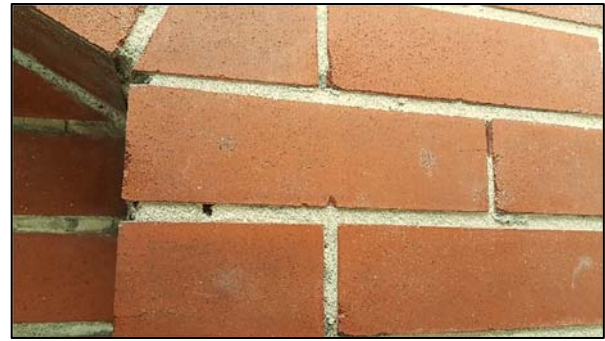
Countersunk anchor holes patched

At the brickwork, countersunk holes were patch filled with custom color-matched Custom 45 mortar.

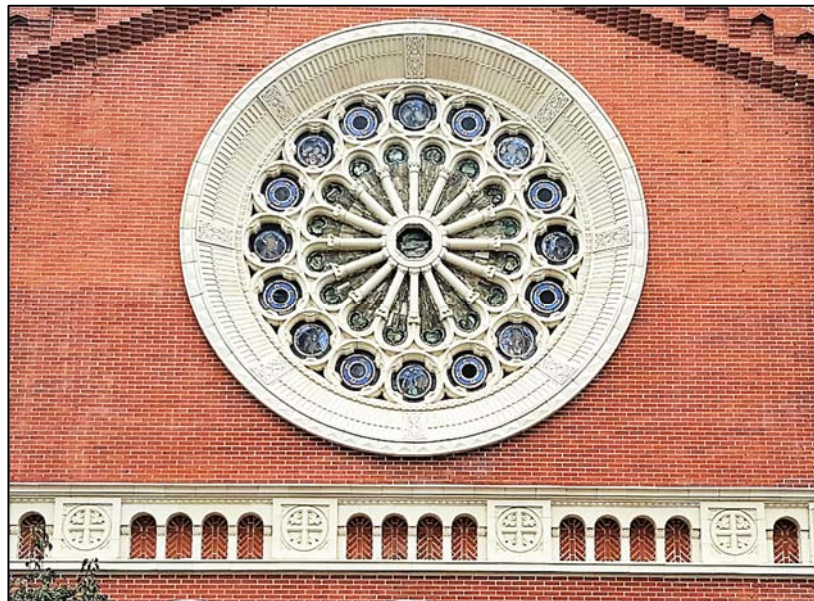
East Rose Window, Frieze and Brickwork Restored
