# RETURN TO WORCESTER UNION STATION

**Owner: Worcester Redevelopment Authority**

**Restoration Architect: Nault Architects, Inc.**

**Restoration Contractor: Kronenberger & Sons Restoration**

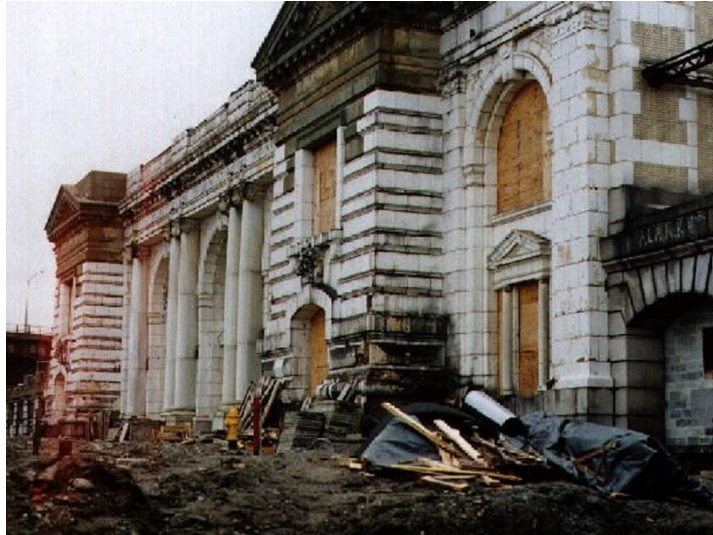
*Figure 1. Worcester Union Station, 1997, described by the terra cotta consultant as in "near-ruin" condition*

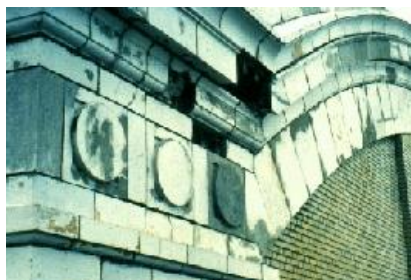
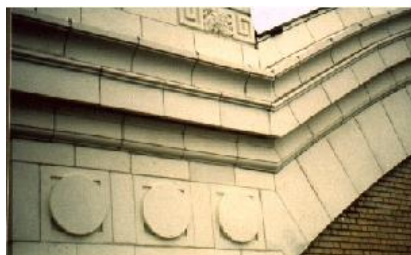
*Figure 2. Section at the top of the North elevation, before and after repair in 1998.*

A detailed moisture study was performed during an intentional pause in the work, to assure that repair mortars and coatings would perform and endure. Loose glaze was scaled aggressively. Thousands of holes were drilled upward into overhanging terra cotta units to prevent accumulation of water within the cavities. 100% repointing was performed. Skyward-facing joints were addressed by installing backer rod and sealant, followed by lead caps being hammered into the surface of the joints.

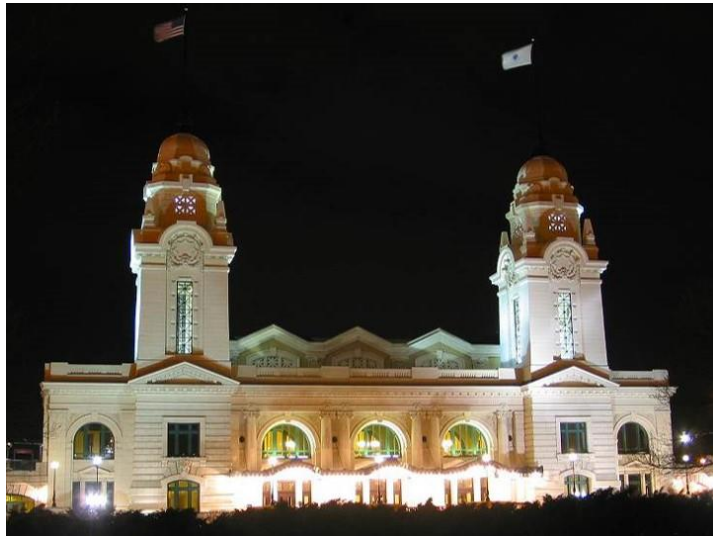
*Figure 3. 2003, North elevation. Five years after restoration and at the conclusion of a modest touch-up campaign, building esthetics remained excellent.*

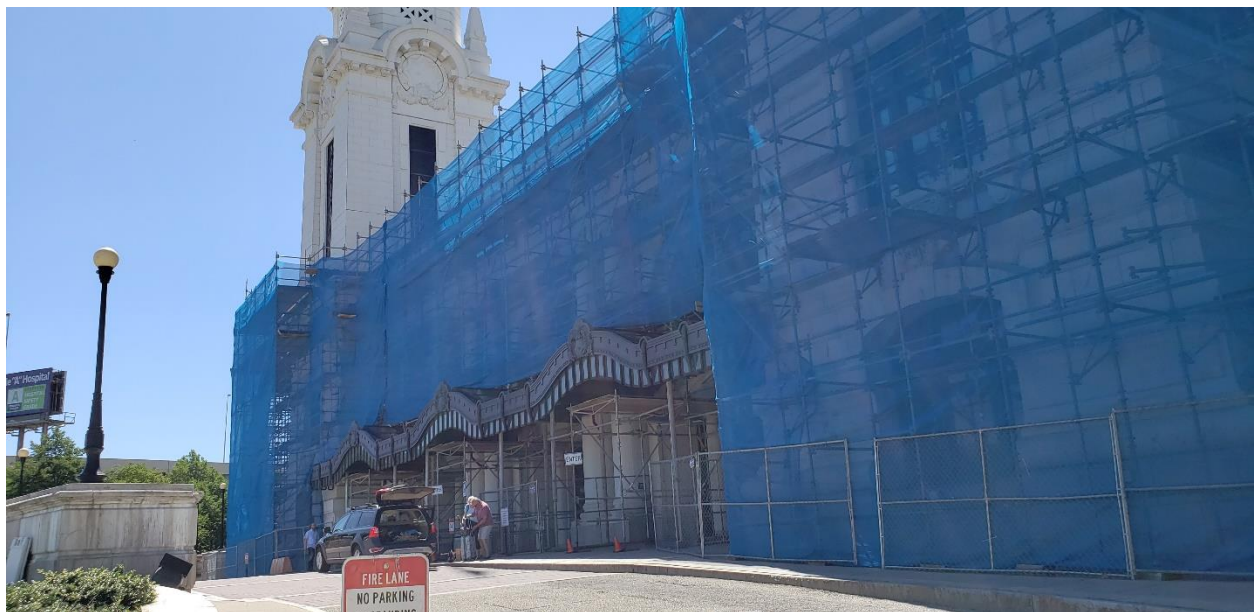
*Figure 4. January 2019, a second major restoration in progress*

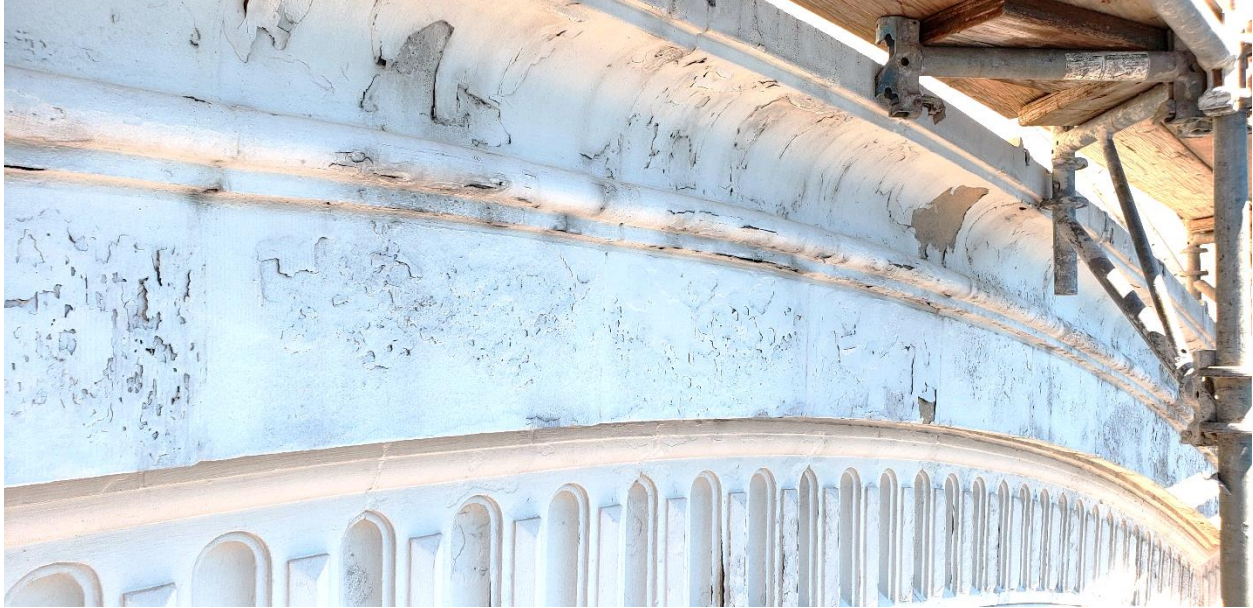
*Figure 5. Widespread glaze spalling, just below the roof level, north facade, 2018*

Damage to the original terra cotta was very extensive, including large areas of new glaze spalls, cracking in the terra cotta alongside some of the lead-capped joints, algae and vegetation growing in wet masonry units and mortar joint delamination. The consultants pointed to roofing defects as the primary cause of the observed problems.

The initial restoration concept was that selective reapplication of Elastowall 351, after proper cleaning and preparation, would preserve the maximum possible amount of the remaining original glaze. As the work advanced, however, it became increasingly evident that overall glaze bond was poor and that much more extensive and aggressive removal of original glaze was necessary.

Product selection included Custom System 45 TC for repairs, Spec Joint 46N with ICE -9RL admixture for repointing and a two-coat glaze consisting of Elastowall 351 base coat and Aquathane UA210E topcoat.

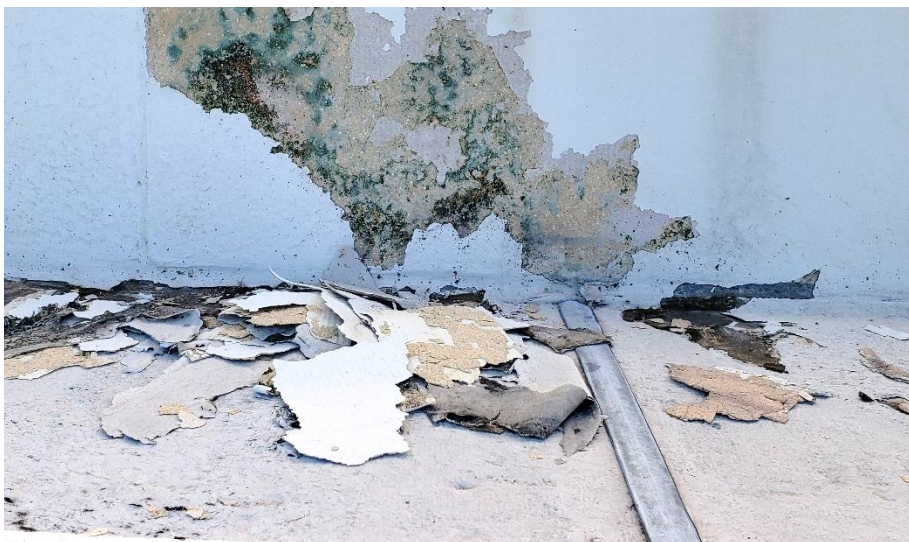
*Figure 6. Glaze spalls reveal biological growth in wet masonry on north elevation parapet.*
