KEY WEST CUSTOMS HOUSE

KEY WEST, FLORIDA

Restoration Architect:

Bender & Associates, Key West, FL

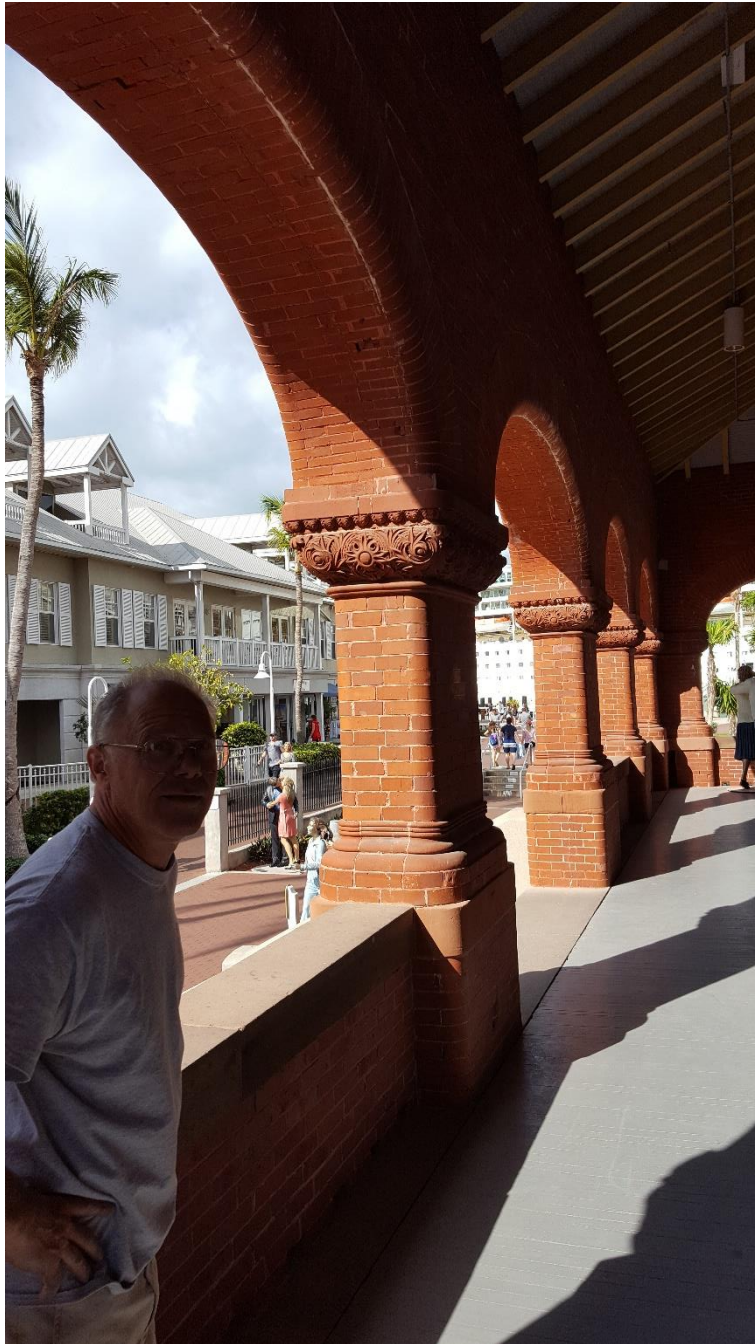
1. 25 years after his initial work was completed, Nelson remains proud of the quality and durability of his work.

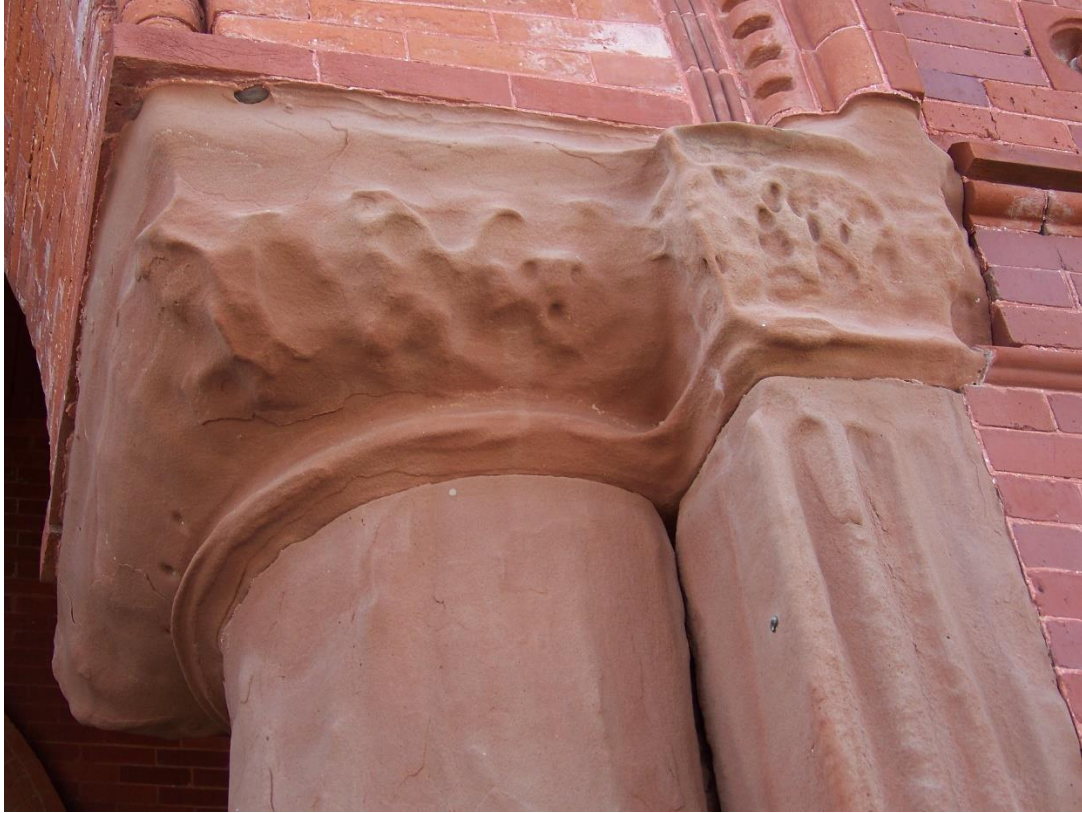
2. Sandstone column, before repair

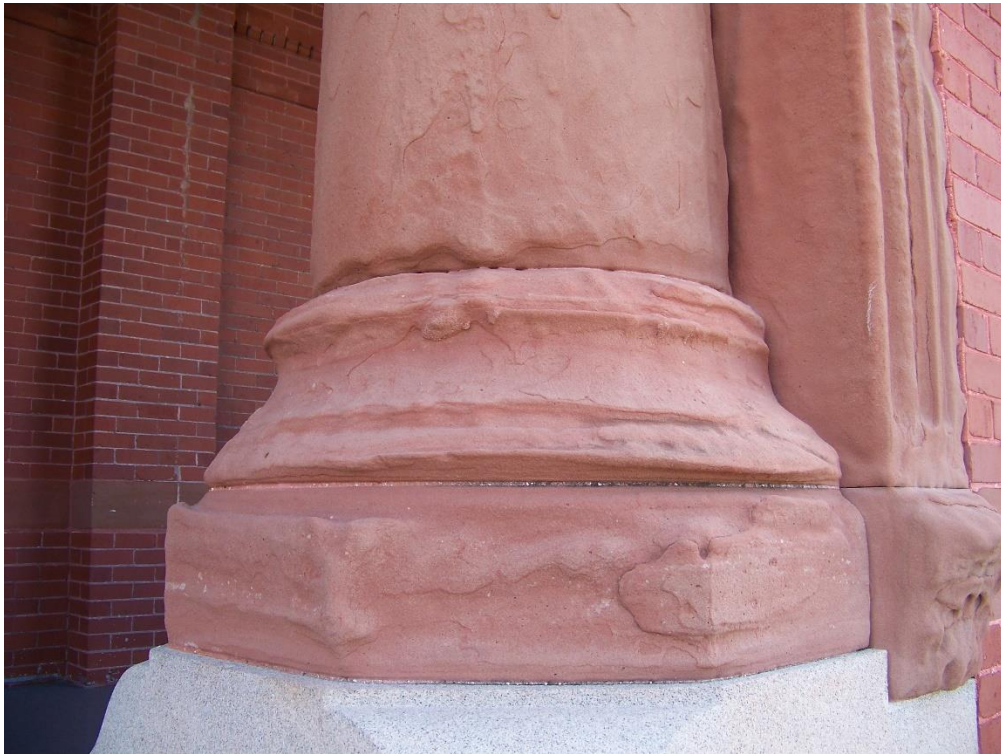
3. Column base, before repair

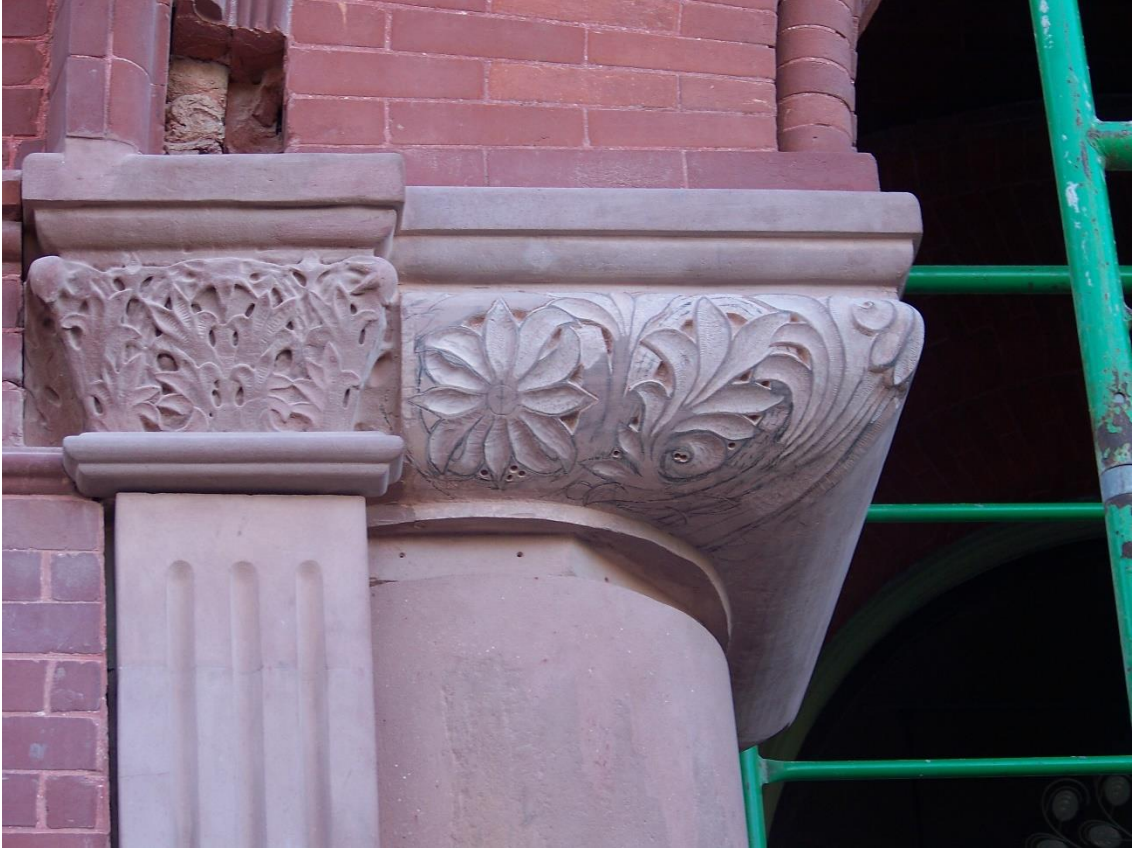
4. Column capital repair, in progress

Using a combination of new stone and [Custom System 45 Type SD](#) sandstone repair mortars, Nelson has been expertly restoring lost details. The work is an enduring tribute to Nelson’s stone-carving skills and artistry.

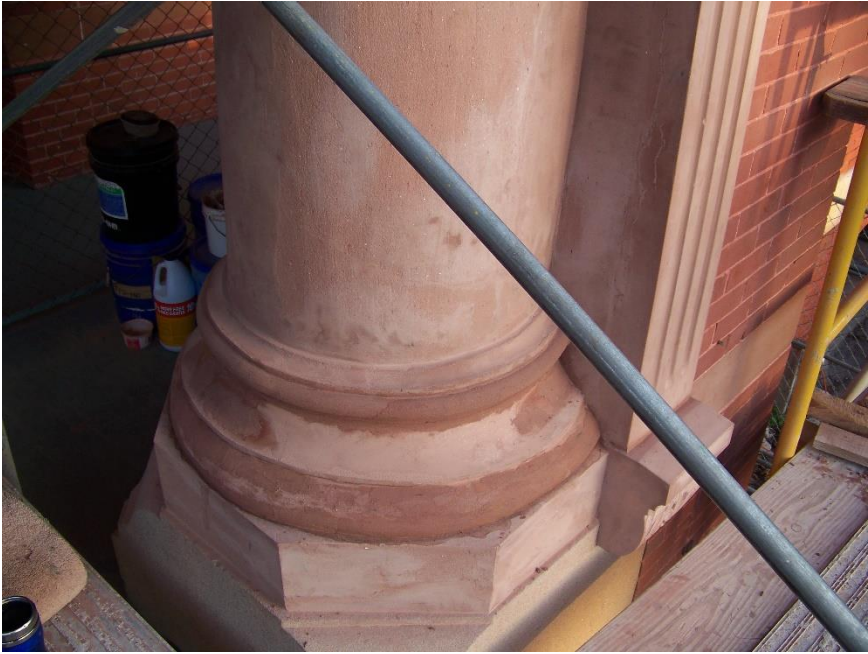
5. Column base repair, in progress

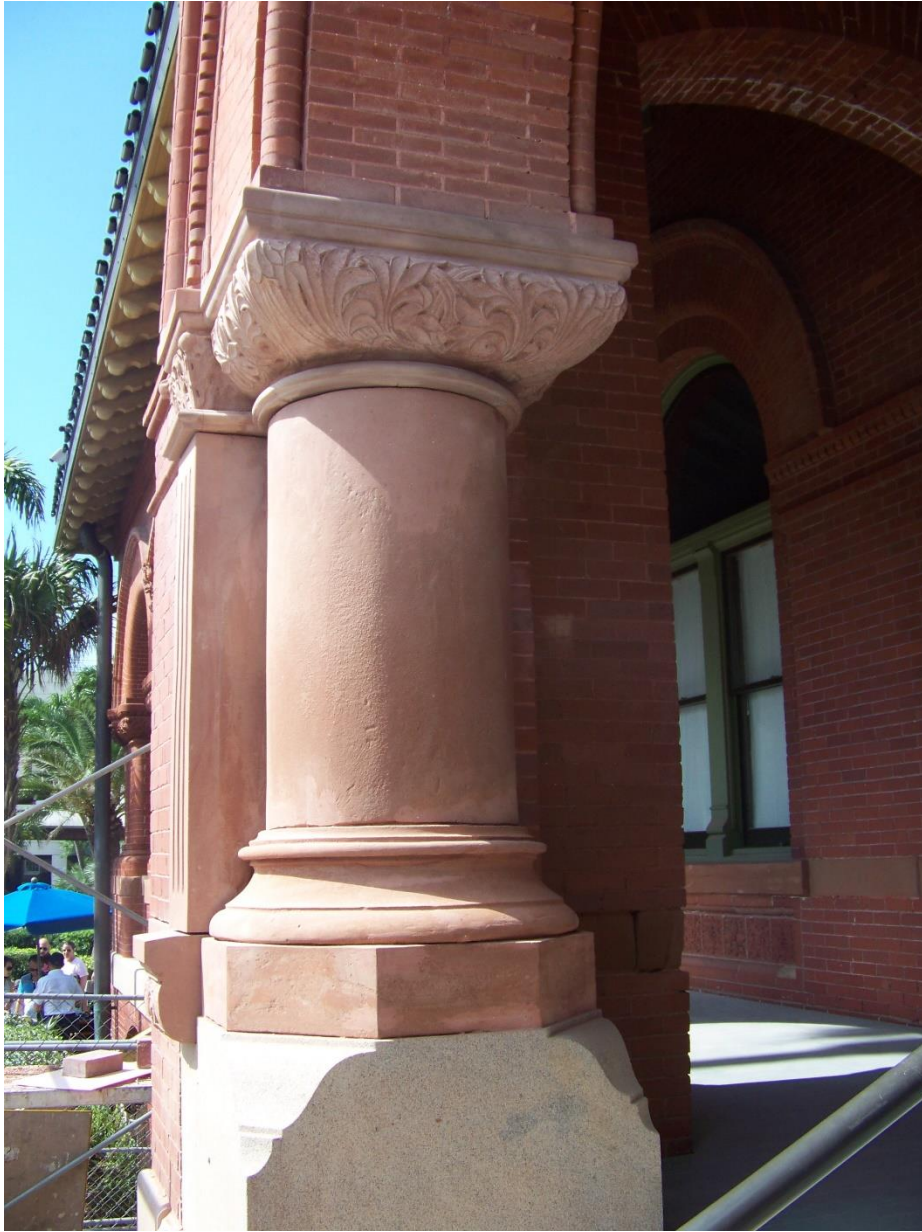
6. Completed column repair
