448 Warren Street, Hudson, NY
*Former First Methodist Church,
Built 1790*

Brownstone Restoration by
[Ganem Contraction Corporation](#)

Product:
[Custom System 45 #701R-SD](#)

Work Performed: 2016

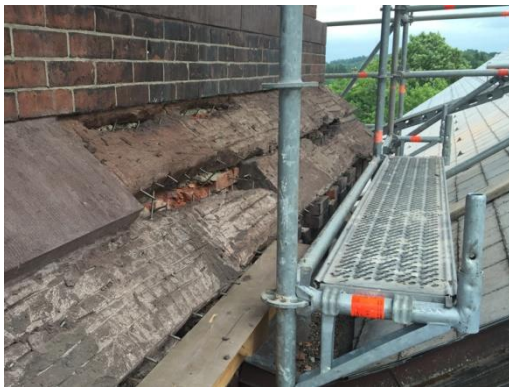
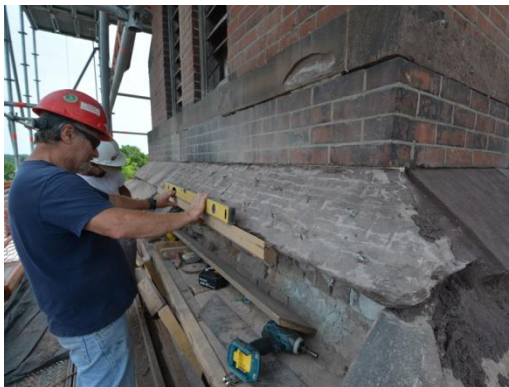
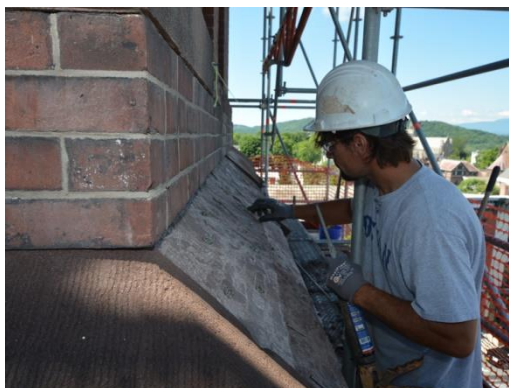
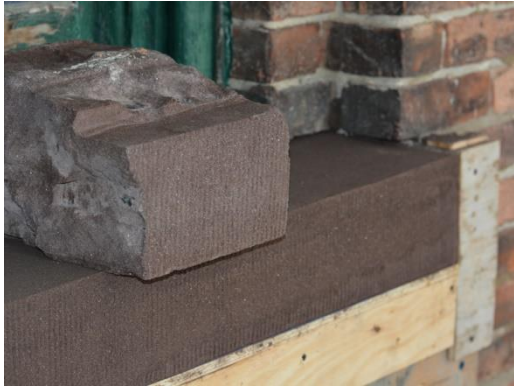
Extensive deterioration of brownstone sills, cornices, belt courses, foundation stones and architectural elements has been repaired by Ganem Contraction using Edison Coatings' Custom System 45 #701R-SD. The photos, courtesy of Ganem, illustrate the process of rebuilding the lost profiles and tooling to

match the original work. Additional photos of work details can be viewed on the [Ganem website](#).

While terms like workmanship can be hard to define, we all know it when we see it, so we will let the photographs speak for themselves. In addition to meticulous surface preparation and anchoring, Ganem properly matched tooling to the original chiseled grooves in the 225-year-old brownstone.

Color was properly selected to be somewhat more intense in the fresh repairs. As the patches fully cure and weather in, reduced

intensity will naturally result in a very close match to the original stone.

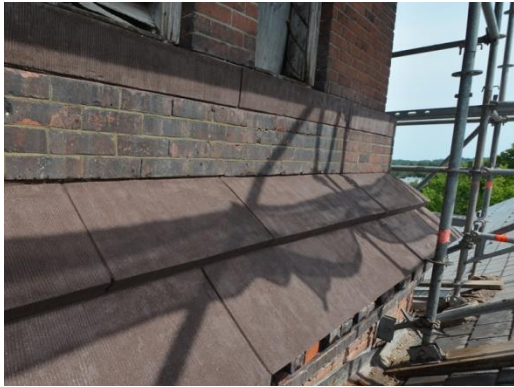
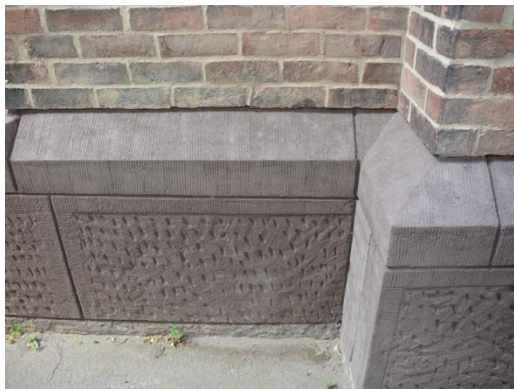
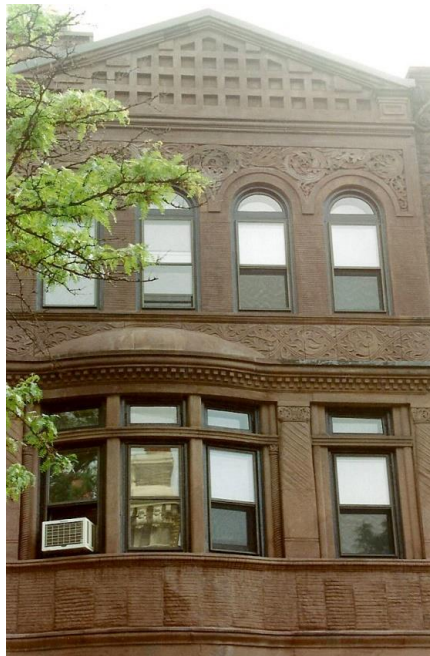
333 State Street,
Albany, NY, restored
1990 by Ganem using
Custom System 45
#701R-SD

Ganem has a long history of successful restoration work utilizing Custom System 45. In 1990 they successfully completed an extremely challenging recreation of complex carved stone ornamentation at [333 State Street](#) in Albany. The project retains excellent appearance and performance, 26 years later.
