Monadnock Building

Brick and Terra Cotta Restoration and Coating
685 Market Street, San Francisco, CA

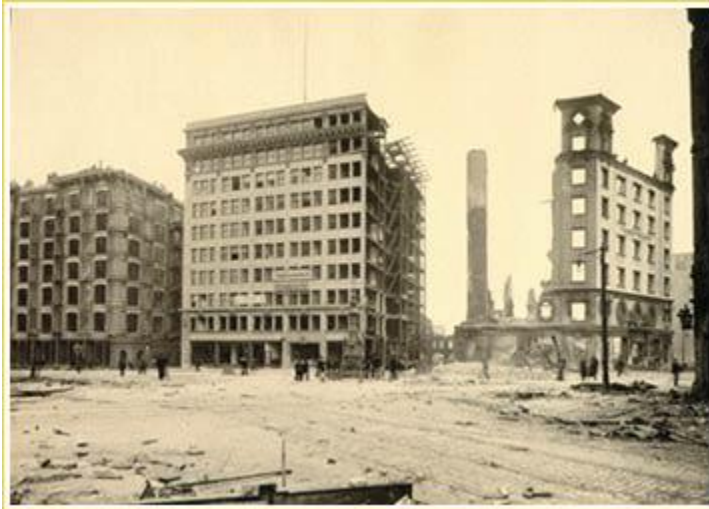
One of the great challenges in the restoration of this building involved the stabilization of the 1906 lime-sand brick on the rear elevation. Existing coatings had been entrapping moisture leaving many of the bricks in poor condition and incapable of supporting the application of a new coating.

Edison Coatings participated in preconstruction testing of its System 95W consolidant on test bricks at our Plainville laboratory, followed by in situ testing on the building. The improvement in strength was sufficient to allow the project to proceed with consolidation, followed by application of Elastowall 351 breathable waterproof masonry coating to the entire back side of the building

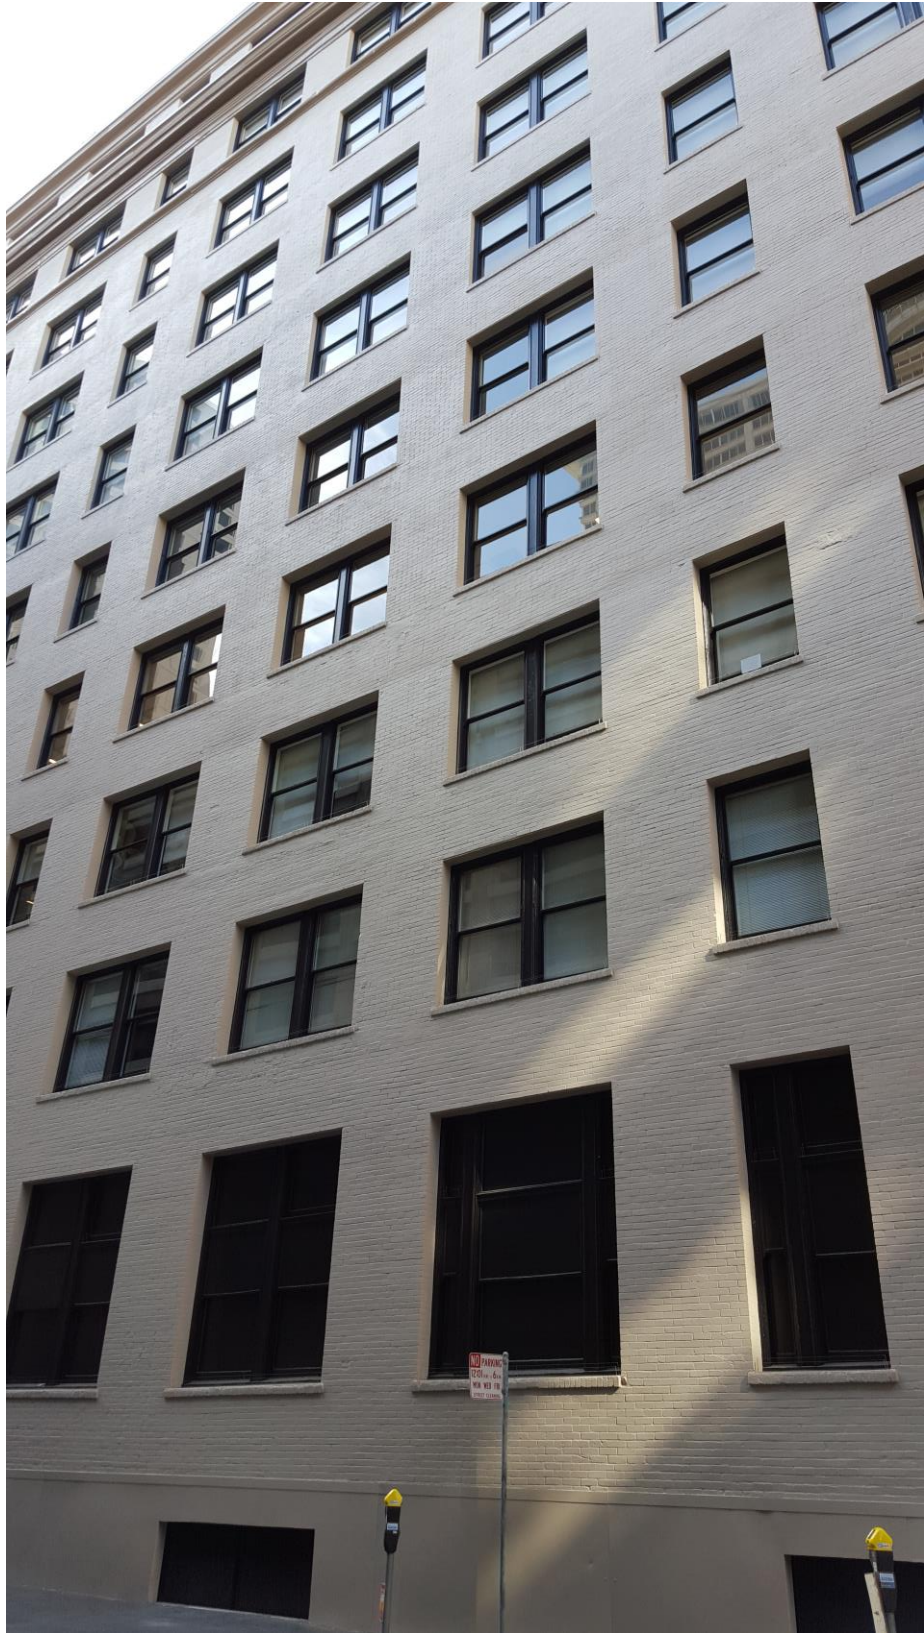
Rear elevation, one year after consolidation with System 95W and coating with custom-matched Elastowall 351.
