## THE RESTORATION OF BROOKLYN NAVY YARD ADMIRAL'S ROW BUILDING B

**Developer:** Steiner NYC  
**Architect:** Thomas A. Fenniman Architect  
**Contractor:** Nicholson & Galloway

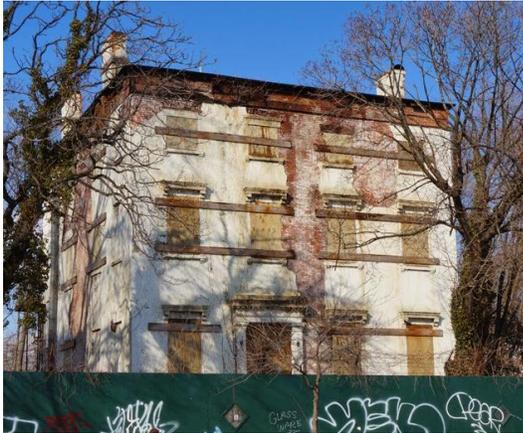
Figure 2. Building B, before restoration

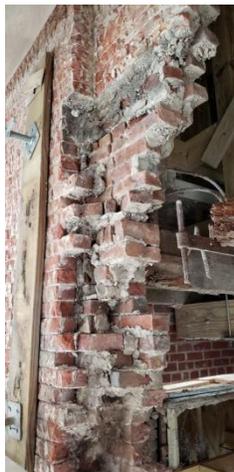
Figure 3. Exposed wall section, revealing poor condition of original assembly

Although the original plan was to consolidate the wall by injection-grouting with BioFlow 35 and repointing with BioMix 35, once work began it became evident that at least the outer wythe was in such poor condition that it required rebuilding.

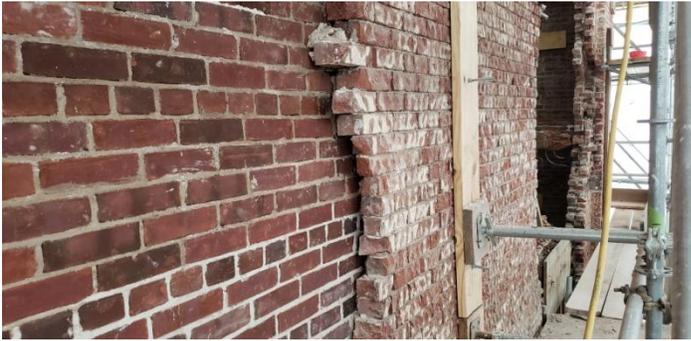
Figure 4. Large sections of the outer wythe were removed and rebuilt.

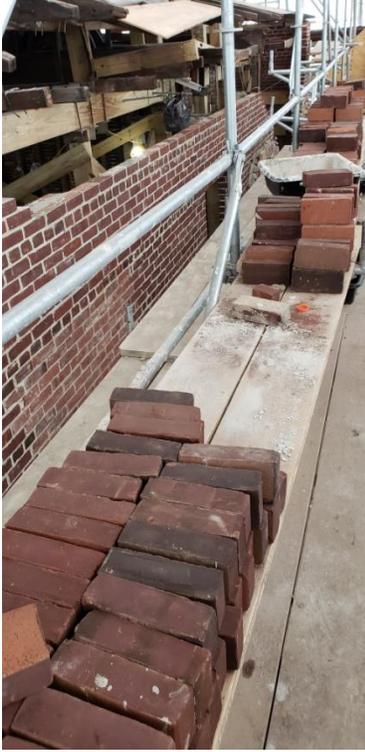
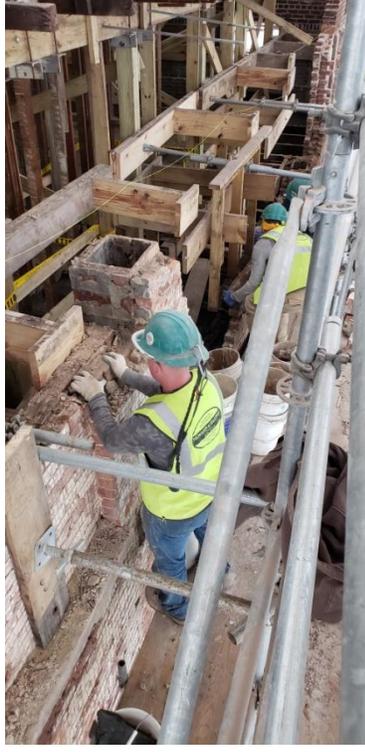
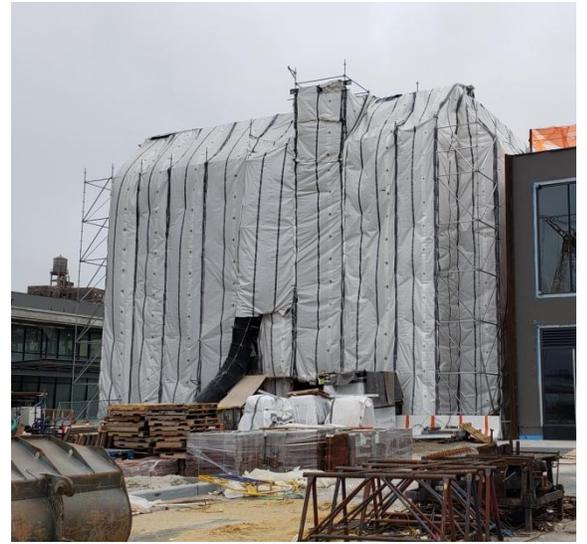
Figure 6. Parapet wall rebuilding in progress using custom-matched BioMix 35
